Case Study

Pharmaceutical Industry

Pharmaceutical manufacturer extends the life of a critical Environmental Conditioning Turbine while avoiding unscheduled outages

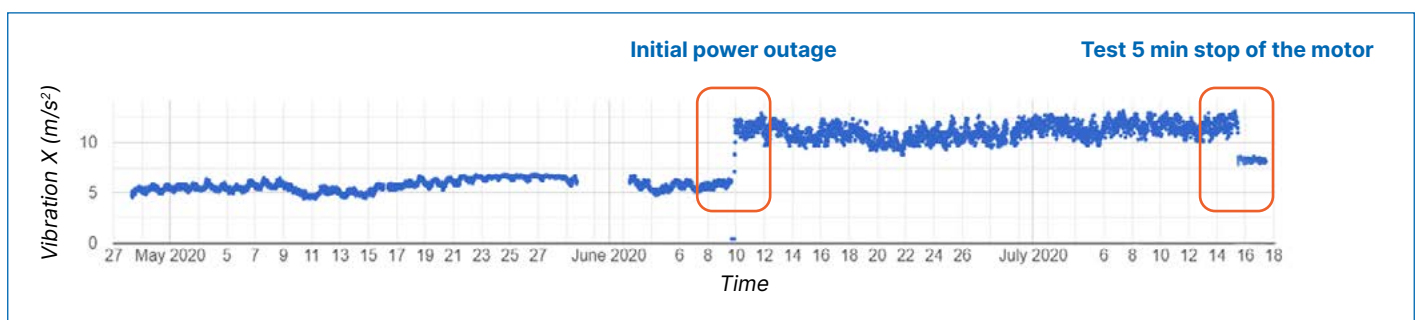
Fault signs

A few months after installation, the room where the air conditioner was located experienced a power outage, which caused the motor to stop for a few hours. After the motor was restarted, the vibration levels increased. This increase in vibration was likely due to a failure in the motor bearing cage, as indicated by the Smart Motor Sensor.

The customer decided to let the motor run for five days in this state: the vibrations remained high, but stable, without any major peaks. The following week, the customer decided to do a test, stopping the motor and restarting it after 5 minutes. The vibration level dropped.

After the test, the vibration level, though still high, remained within acceptable limits. The severity level of the fault indicated that failure was not imminent, allowing the manufacturer to wait until the next maintenance period to replace the bearings.

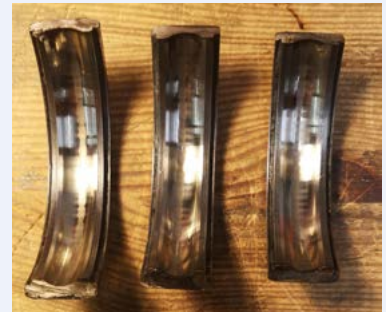
Inner track

Visual confirmation of the fault

Advanced wear of bearing races.

At the next inspection, the maintenance team confirmed the worn condition of the bearings and decided to change the motor.
